# Manhole Inspection Summary

Manhole # S53E\_\_023MH

Insp Date: **4/29/08 8:05 AM**

**Location** Address: **128 s bouldin st**

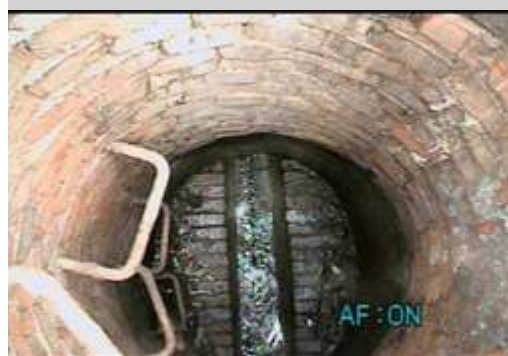
misc

channel debris

bench debris

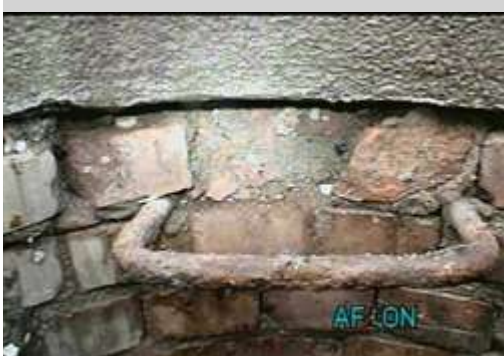
Defect 1

**Steps** Count: **5** Missing: **0** ☒ Corroded

steps

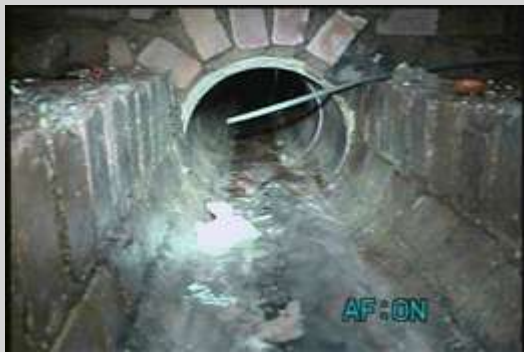
12 O'Clock Outflow

8 in. Circular Gravity Sewer  
Pipe Out @ 12 O'Clock

Invert Depth: **9.30** (ft.) Flow Characteristics: **Turbulent**

Infiltration: **None** Pipe Seal Cond: **Unknown**

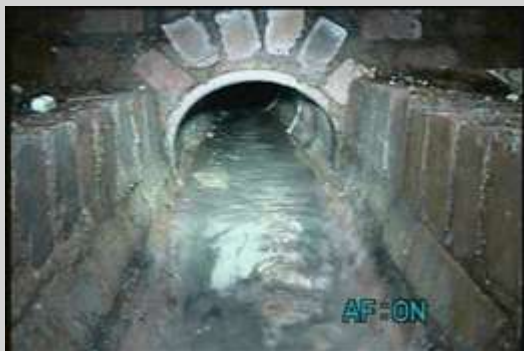
6 O'Clock Inflow

8 in. Circular Gravity Sewer  
Pipe In @ 6 O'Clock

Invert Depth: **9.10** (ft.) Flow Characteristics: **Fast**

Infiltration: **None** Pipe Seal Cond: **Unknown**
